DEFECT REPORT

For the Property Identified As 'Nothing'

0 Nowhere St, Nowhere, NSW 0000

Issue Date: February 2019

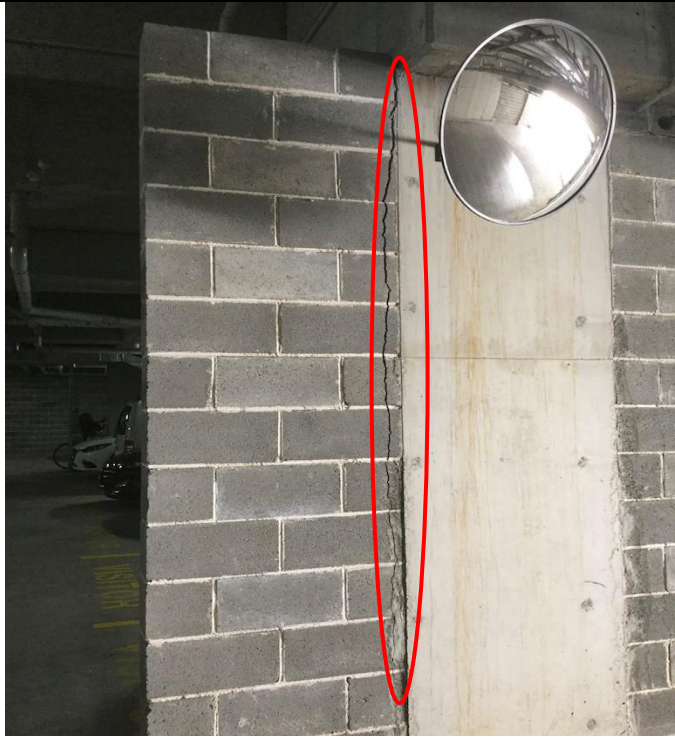
Item No.	Item Description & Cause	References (if applicable)	Brief Scope of Rectification Works	Photographic Record
Basement/Carpark				
<p>2.1.</p>	<p>Carpark</p> <p>Block blade wall on eastern side of main entry gate cracked for full height. Fault due to differential movement between blockwork and preformed concrete.</p> <p>Damage Category: 4 Severe crack.</p>	<p>National Construction Code</p> <p>Building Code of Australia Performance Requirements.</p> <p>BP1.1 A building or structure, during construction and use, with appropriate degrees of reliability, must perform adequately under all reasonably expected design actions including, but not limited to differential movement.</p>	<p>Dismantle blockwork wall and rebuild with movement gap between blockwork and precast concrete.</p> <p>Install foam barrier in vertical joint and fill with construction sealant and tool flush in accordance with manufacturer's recommendations and AS 3700.</p> <p>Refer to Appendix A: Expansion Joint Schematic.</p>

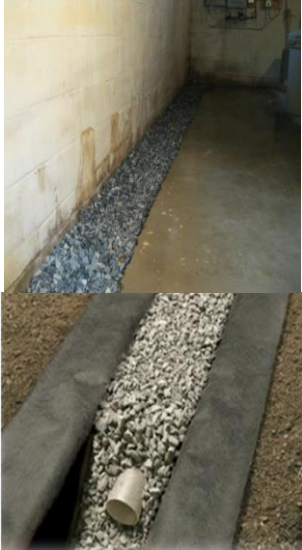
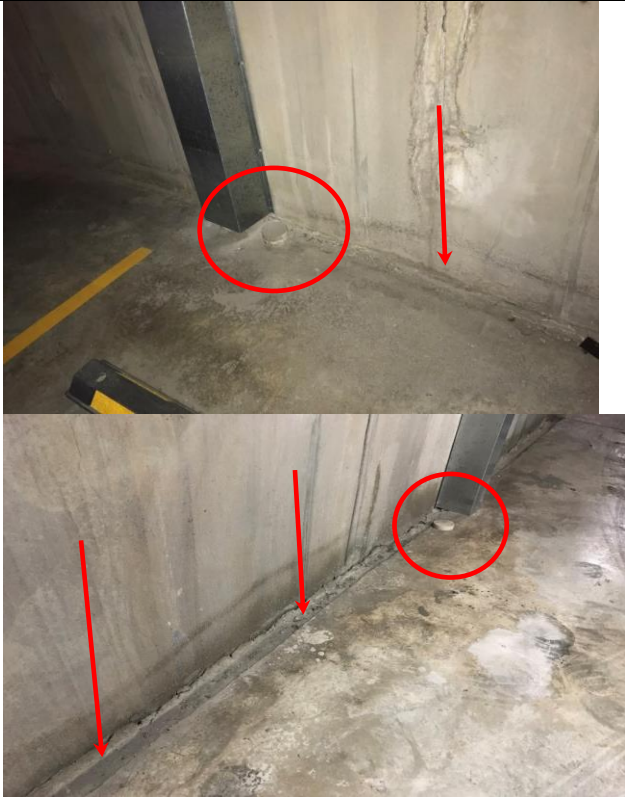
Item No.	Item Description & Cause	References (if applicable)	Brief Scope of Rectification Works	Photographic Record
<p>2.2</p>	<p>Carpark</p> <p>Trench drains behind car spaces: A605 A1104 B502 B503</p> <p>Trench drains are not connected to storm water catchment pit. Drain inlets are capped.</p> <p>Trench drains are poorly formed.</p>	<p>Australian Standard AS 3500.3 Plumbing Drainage and Stormwater Drainage. Section 6 Surface and Subsoil Drainage Systems.</p> <p>Home Building Act 1989 Section 18 - Warranty Breach, poor workmanship and unsightly.</p>	<p>Cut open line of trench drain and re-form with sufficient fall to drain inlet.</p> <p>*Preferably fit Ag pipe to discharge into drain inlet. Fill newly formed trench drain with blue metal.</p>

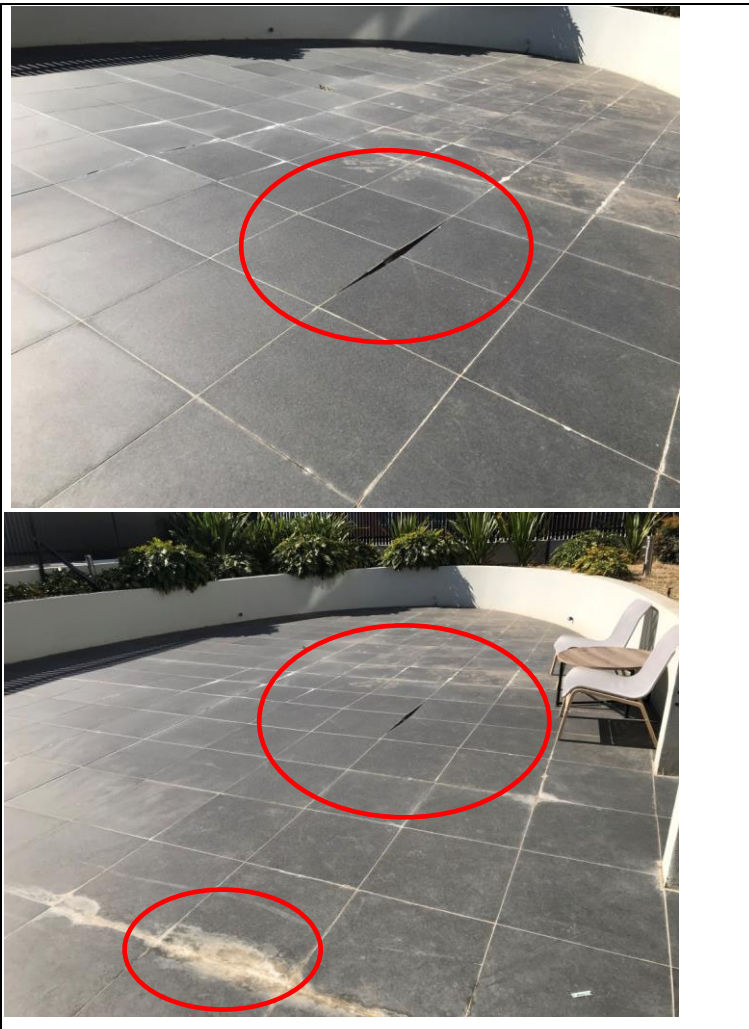
Item No.	Item Description & Cause	References (if applicable)	Brief Scope of Rectification Works	Photographic Record
Common Areas				
<p>2.3</p>	<p>Block B Level 7 Terrace Area</p> <p>Tiles on terrace lifted due to expansion during temperature changes and variations in moisture content. No expansion joints were provided for during the laying of tiles contrary to the requirements of AS3958.1 – Ceramic Tiles Guide to the installation of ceramic tiles.</p> <p>Calcification and efflorescence on tiling suspected to be due to defective membrane or damp proofing. Residential area below terrace.</p>	<p>AS3958.1 Section 5.4.5.2 (b) – Intermediate movement joints. Intermediate joints should be provided in evenly spaced positions at approximately 4.5m centres, or at locations where stress might reasonably be expected in – (ii) External floors where any dimension exceeds 4.5m.</p> <p>AS4654.1-2012 Waterproofing membranes for external use above ground.</p> <p>Home Building Act 1989 Section 18 - Warranty Breach, poor workmanship and unsightly.</p>	<p>Remove lifted tiles and determine quality and condition of waterproof membrane. Ensure compliance with AS4654.1-2012. If necessary, remove all tiles, prepare substrate and apply waterproof membrane in compliance with AS4654.1.</p> <p>Lay tiles with intermediate movement joints in compliance with AS3958.1. (See diagram below)</p> <p>When re-grouting tiles ensure that washed sand is used and/or treated with anti-efflorescence product such as Efflorescence Rid.</p> <p>Refer to Appendix A: Expansion Joint Schematic.</p>

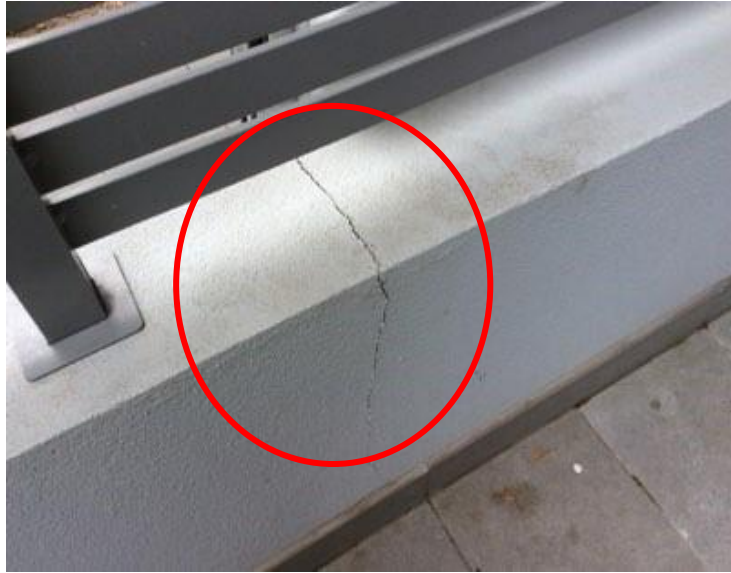
Item No.	Item Description & Cause	References (if applicable)	Brief Scope of Rectification Works	Photographic Record
Common Property in Units				
G01.01	Balcony Unsightly finish to balcony render. Crack to render finish.	Home Building Act 1989 S18. Warranty breach, poor workmanship and unsightly. NSW guide to Standards and Tolerances: 10.4 Cracking or other blemishes in rendered or hard plastered surfaces on a masonry substrate. AS2870 provides: If the crack is between 1mm-5mm it will constitute slight repair by filling the crack with caulking or a cement product.	Clean area and remove any debris from the affected area. Fill crack with caulking or cement product. If required, re-paint area to match adjacent areas.

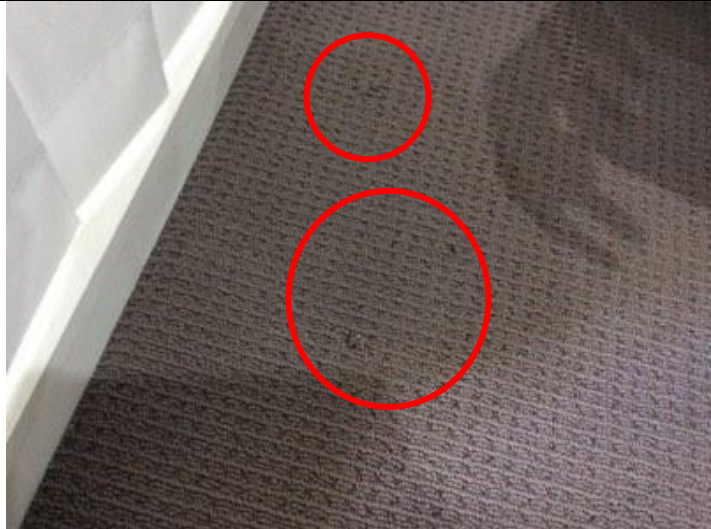
Item No.	Item Description & Cause	References (if applicable)	Brief Scope of Rectification Works	Photographic Record
<p>G01.02</p>	<p>Main Bedroom</p> <p>Carpet is pulling and generally poor quality throughout bedroom.</p>	<p>Home Building Act 1989 S18.</p> <p>Warranty breach, poor workmanship and unsightly.</p> <p>NSW Guide to Standards and Tolerances:</p> <p>S19.10 Floor Coverings.</p>	<p>Confirm if carpet, smooth edge and any other underlay have been installed to manufacturer's installation instructions; if yes, this is not a builder's defect.</p> <p>If no, carpet is to be removed and reinstalled according to manufacturer's installation instructions.</p> <p>Please note carpet is not referenced in the BCA or AS. Carpet falls under provisions of consumer law and can be assessed under product quality regulations if the install is not classified as defective workmanship.</p>
